Inspection Report Minerals Regulatory Program

Mine	e Name: Snow White	Permit Number:	M/049/0030	Permi	t Fees:	Paid	
Ope	rator Name: Interstate Brick Co.	Inspection Date:	08/06/2013	Bond	Amount:	\$143,300.00	
Insp	ector(s): A. Abate, J. Hewitt, F. Delliskave	Time:	10:30 AM	Bond	Escalation:	01/31/16	
Othe	ers:	Mine Status:	Active				
Elements of Inspection					Comment	Enforcement	
1.	Permits, Revisions, Transfer, Bonds						
2.	Public Safety (shafts, adits, trash, signs, highwalls)						
3.	Protection of Drainages/Erosion Control						
4.	Deleterious Material						
5.	5. Roads (maintenance, surfacing, dust control, safety)						
6.	Reclamation				V		
7.	Backfilling/Grading (trenches, pits, roads, highwalls, shafts)			V	V		
8.	Soils						
9.	Revegetation						
					-

Mine: M/049/0030 Inspected: 08/06/2013

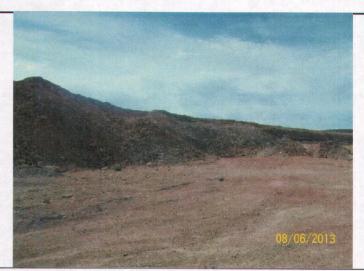
The operator pointed out a berm area on the west side of the lower pit of the mine that had been reclaimed. The operator explained that reclamation was planned as the overburden from the mine highwall would be placed in front of the berm (to the east) and then seeded. The operator explained that there was no topsoil salvaged at this mine. We discussed using biosolids as a possible option to help enhance vegetation growth. The operator explained that there were some biosolids available for free from a dealer in the Orem area but it had landfill waste contained within it. From the sounds of it, this particular biosolid material would be undesirable to use at this site. Discussed other areas within the permit boundary that could be contemporaneously reclaimed. A large pile of material on the area on the north side of the lower pit was pointed out as an area that could be reclaimed (see photo). Another area was the south pit where active mining has been ongoing. There is a large flat area that was formerly used to stage clay product. The clay product is gone but the area could be reclaimed as it is a large flat surface that looks much like a parking lot. This area could be roughed and seeded as part of the contemporaneous reclamation plan.

In accordance with R647-4-107.6,	The operator sho	uld amend their	plan to add the a	reas discussed	during today's	s inspection as are	as planned
for contemporaneous reclamation.	11011	/
